The Results of UEC-1's First Deployment

15 OCT 98 to 25 NOV 98

UEC-1 was deployed for approximately 6 weeks submarine NR-1

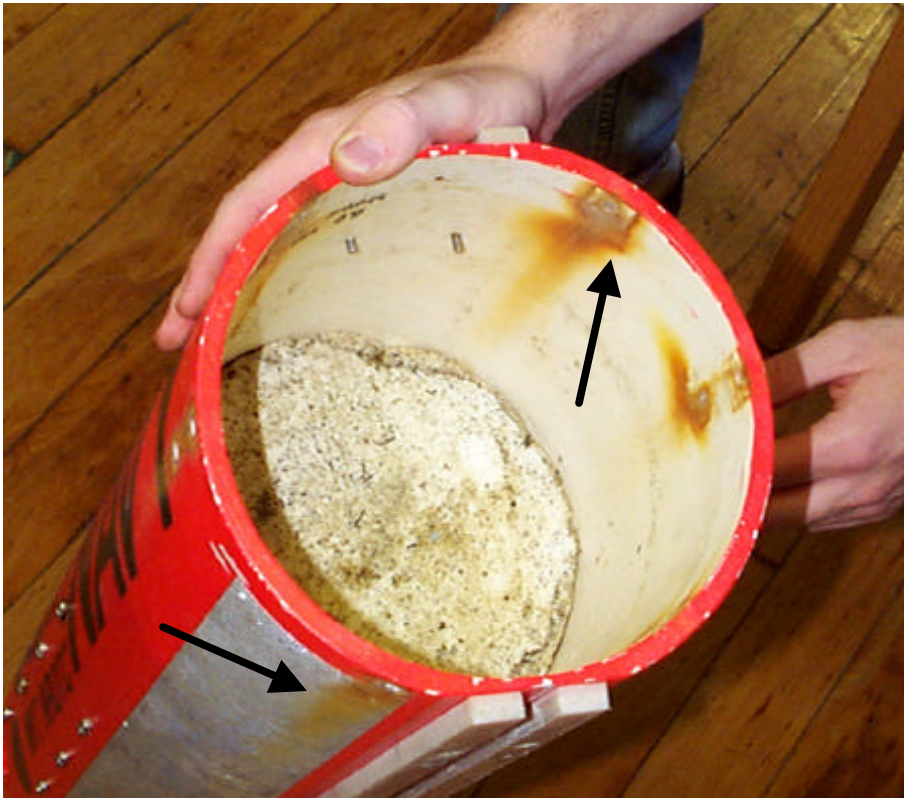
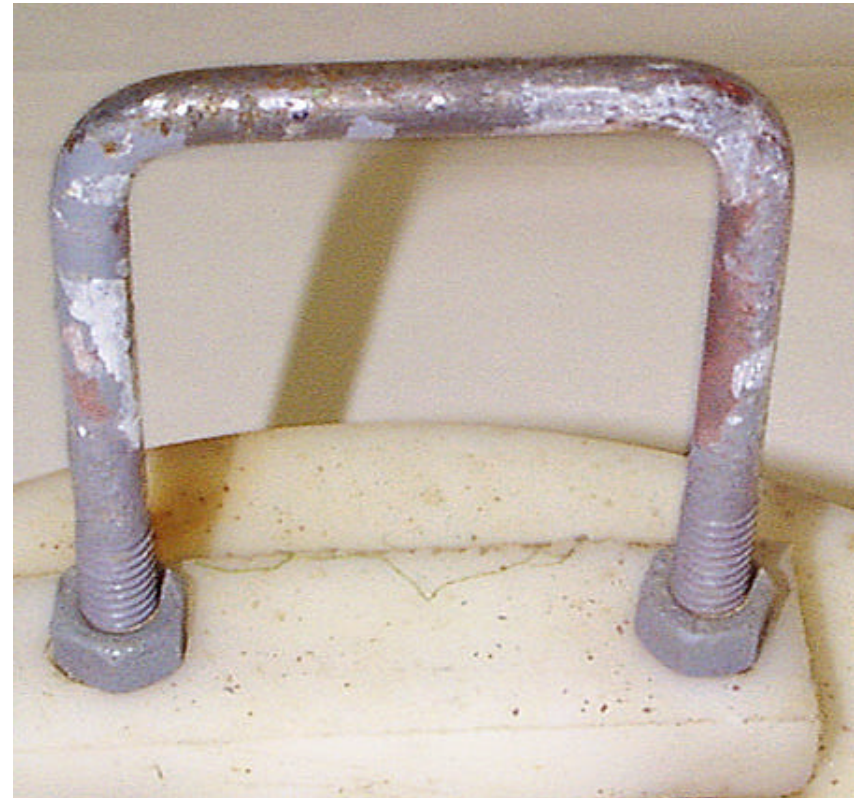
UEC-1 was found to be in good condition after it's initial deployment.

There was some mild corrosion around the stainless steel screws, and the zinc plated u-bolt.

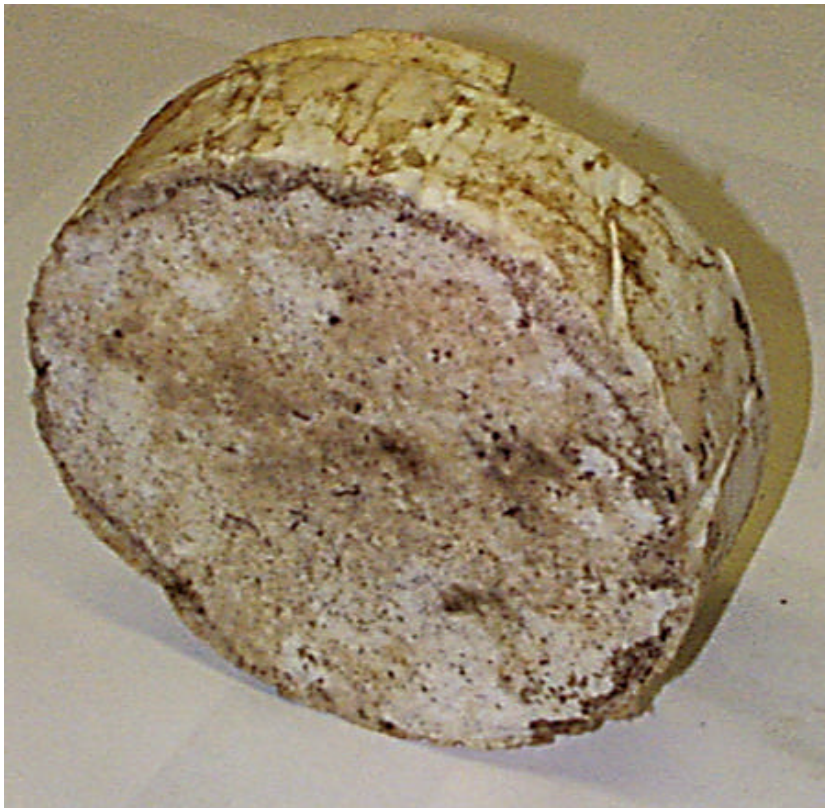
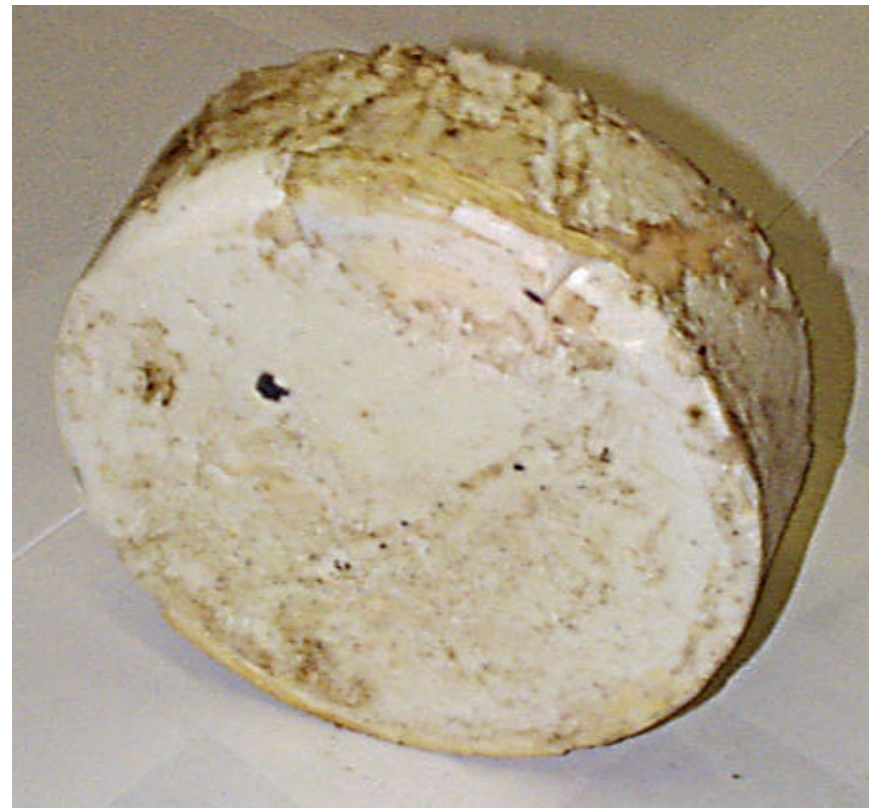
The crudely made block of syntactic foam survived.

The block measured 2" thick and 8" in diameter.

Notice the large amount of sediment that collected on the top and the sides of the foam block.

The amount of sediment increased toward the bottom of the UEC. It was blown in from the bottom by NR-1's aft thrusters.

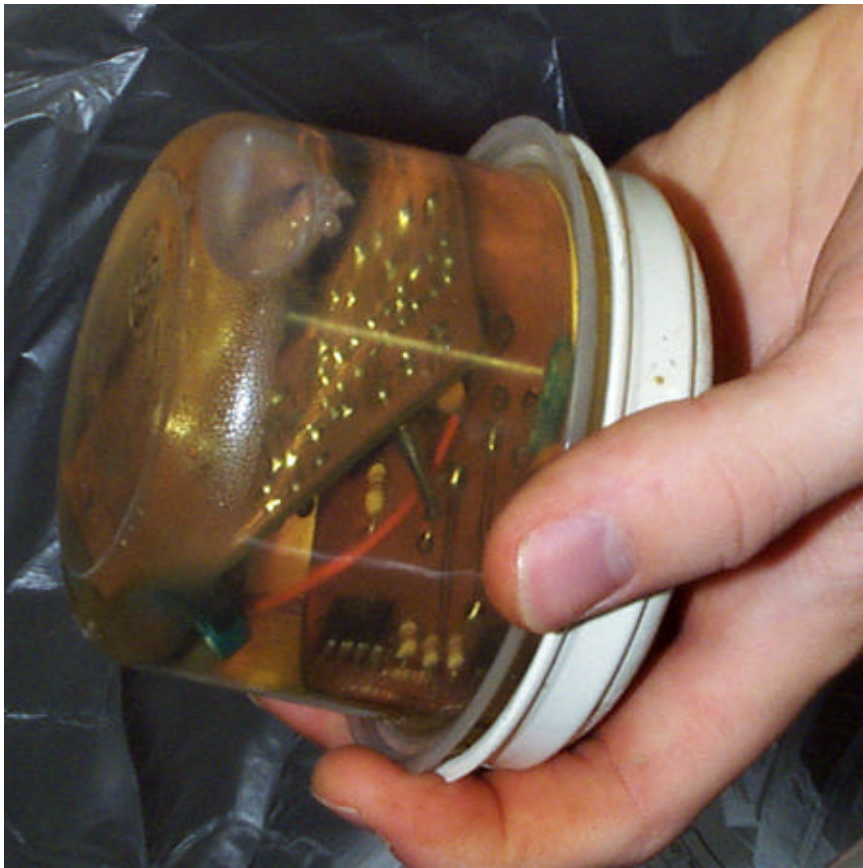
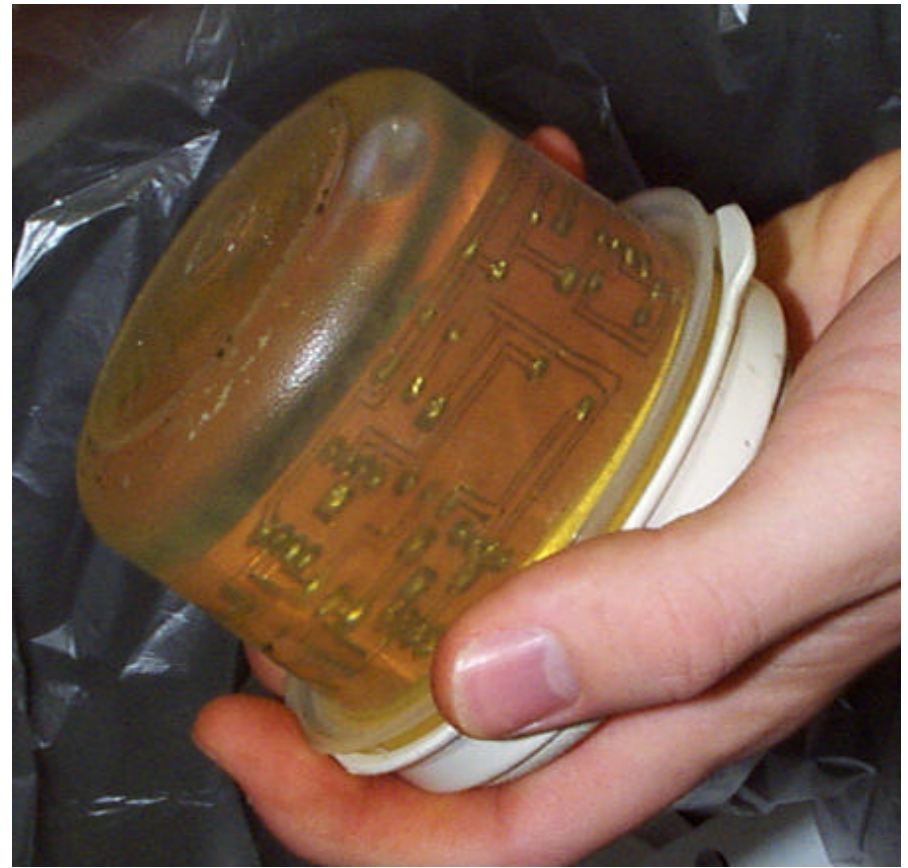
Using the Rubbermaid tupperware as compensated containers for the circuits was not a success.

3 to 5 cc of sea water was admitted to each container.

Each container also had an air bubble in it.

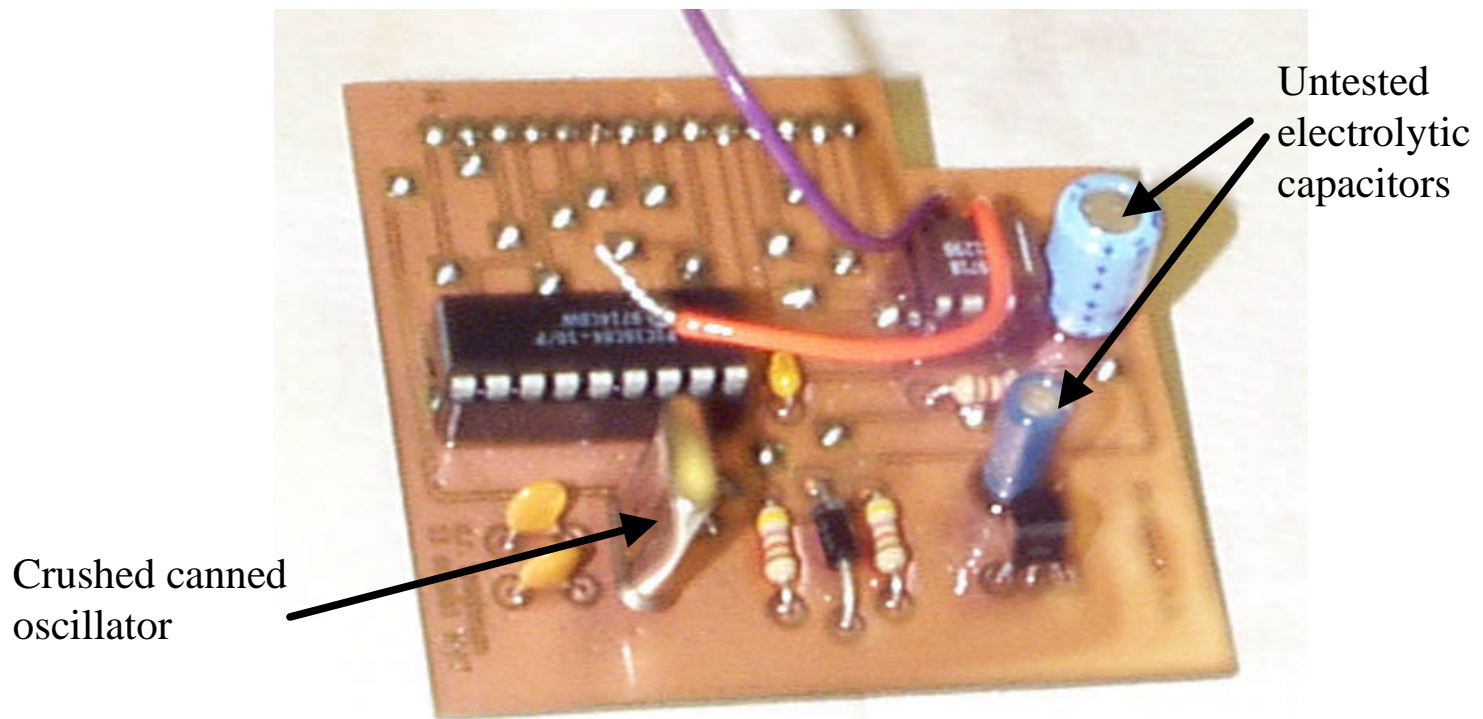
The only electronic components that were obviously damaged were the canned oscillators associated with the PIC's. We are also fairly sure the electrolytic capacitors were affected, however, we have not tested these yet.

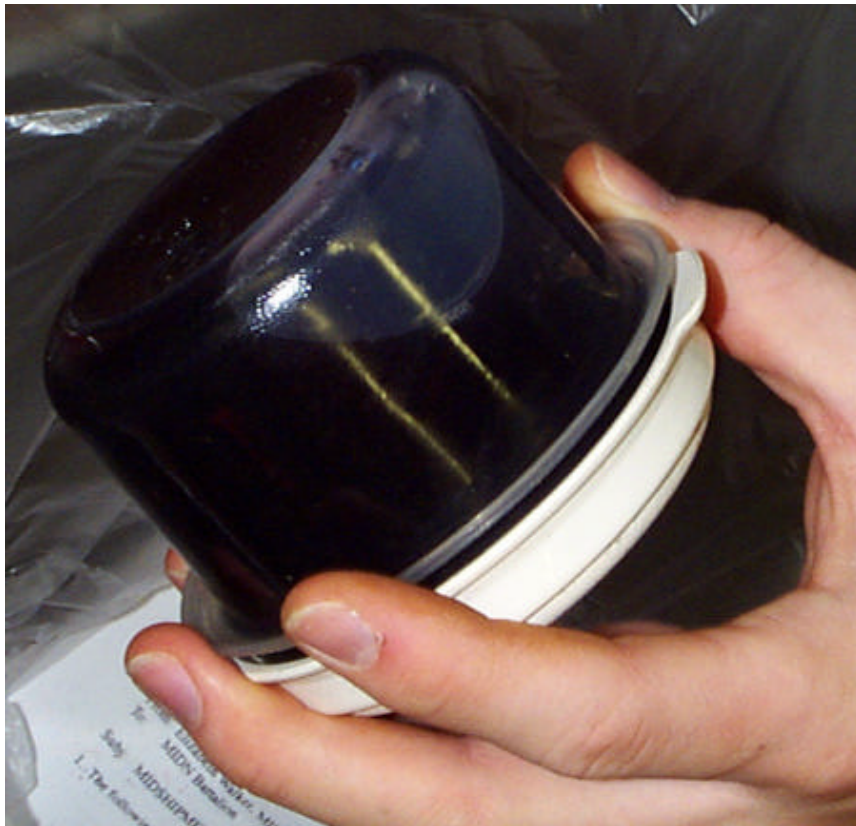
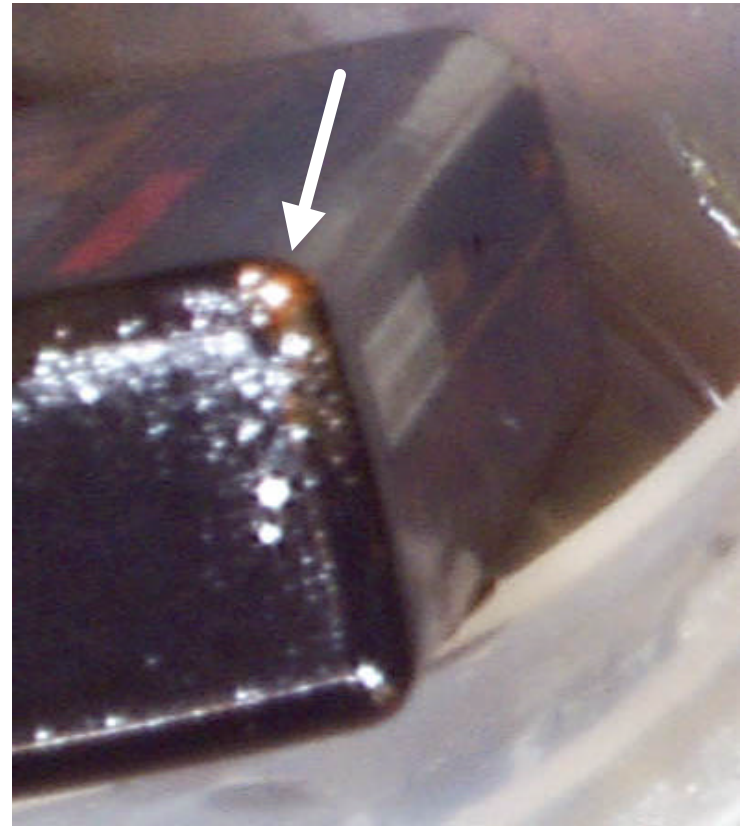
As expected the 9 volt Alkaline batteries were crushed.

Notice the contaminated compensation fluid in the left-hand photo and the corrosion at the corner of the battery in the right-hand photo.

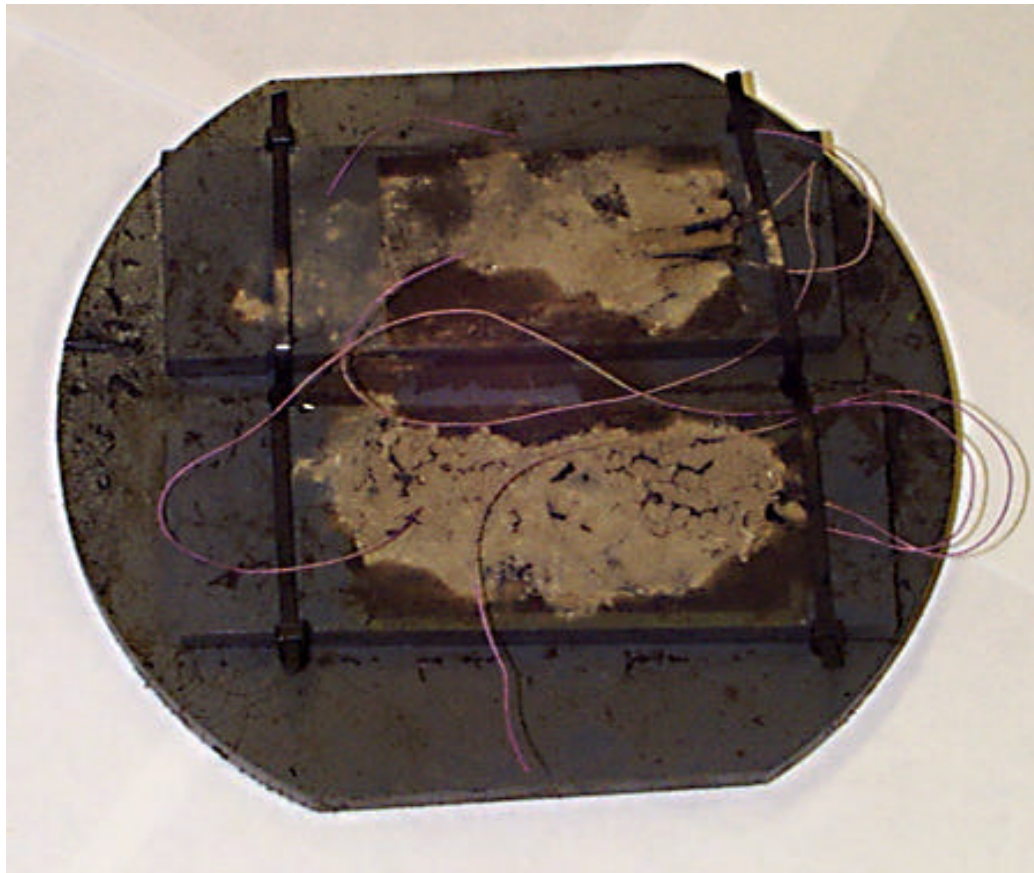
The strain gages have been tested since their return. All three were found to be working correctly.

The photo below shows the two gages that were placed on the lowest pallet. Notice the large amount of mud that collected there during the deployment.

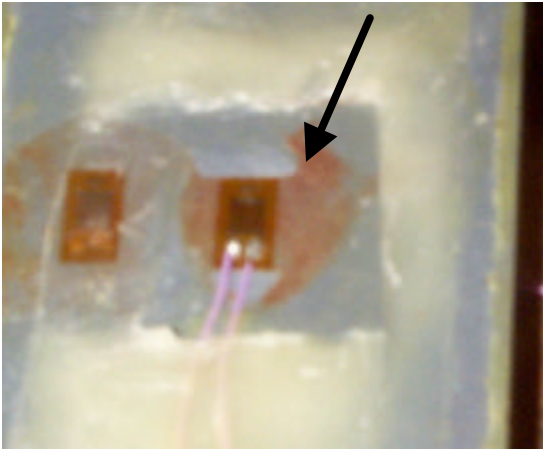
Teflon Tape and Wax Coating

While the strain gages did function well upon their return, we did notice that the adhesive used to attach the gages to the PVC changed color (from clear to a rust brown see photos above). This happened regardless of the coating type.

We are still investigating the cause of this discoloration. The explanations we have thought of to date are:

- It could be a reaction to the pressure.
- Particles from the gage may be sticking to the adhesive.
- These could be rust particles (or other waterborne sediment) that may have become stuck to the adhesive.

This may indicate that seawater did leak under the coating to the gages.

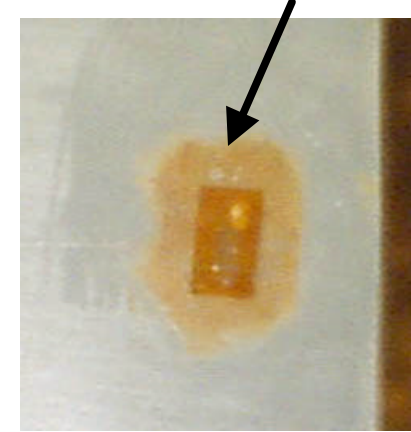
*No Tape and No Coating
(gage and adhesive
exposed to seawater)*

We are still examining the gages and we may have found a very small amount of corrosion on the coated solder joints (the un-coated joints were completely corroded).
